## 1802-1804 S Viewcrest Septic Tank Locations

**SEPTIC SYSTEM INSPECTION REPORT**

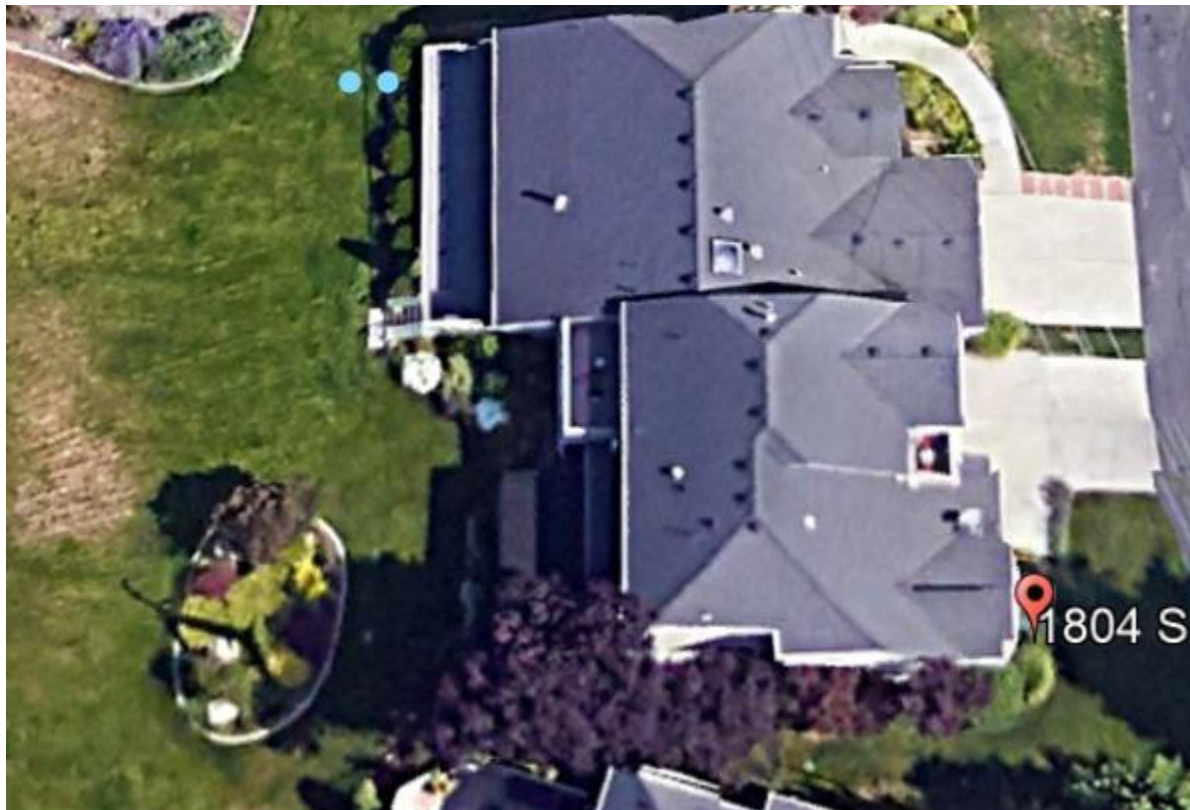
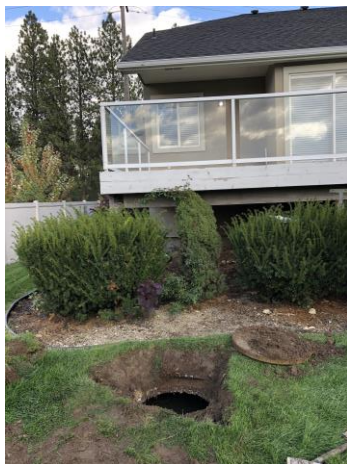
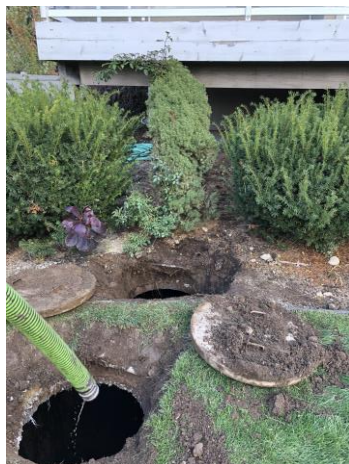
The septic tank locations for 1802-1804 S Viewcrest Ln are identified by the two blue dots, and are just slightly SW of the NW corner of the 1802 deck. They are 3' and 6' feet from the westernmost edge of the deck, and 43" south of the NW corner of the deck. One is just outside the edge of the bed, and one is just inside the edge of the bed. The openings are between 12-14" below ground.

Note: Two Irrigation water lines run along the east edge of both tank openings. Dig carefully

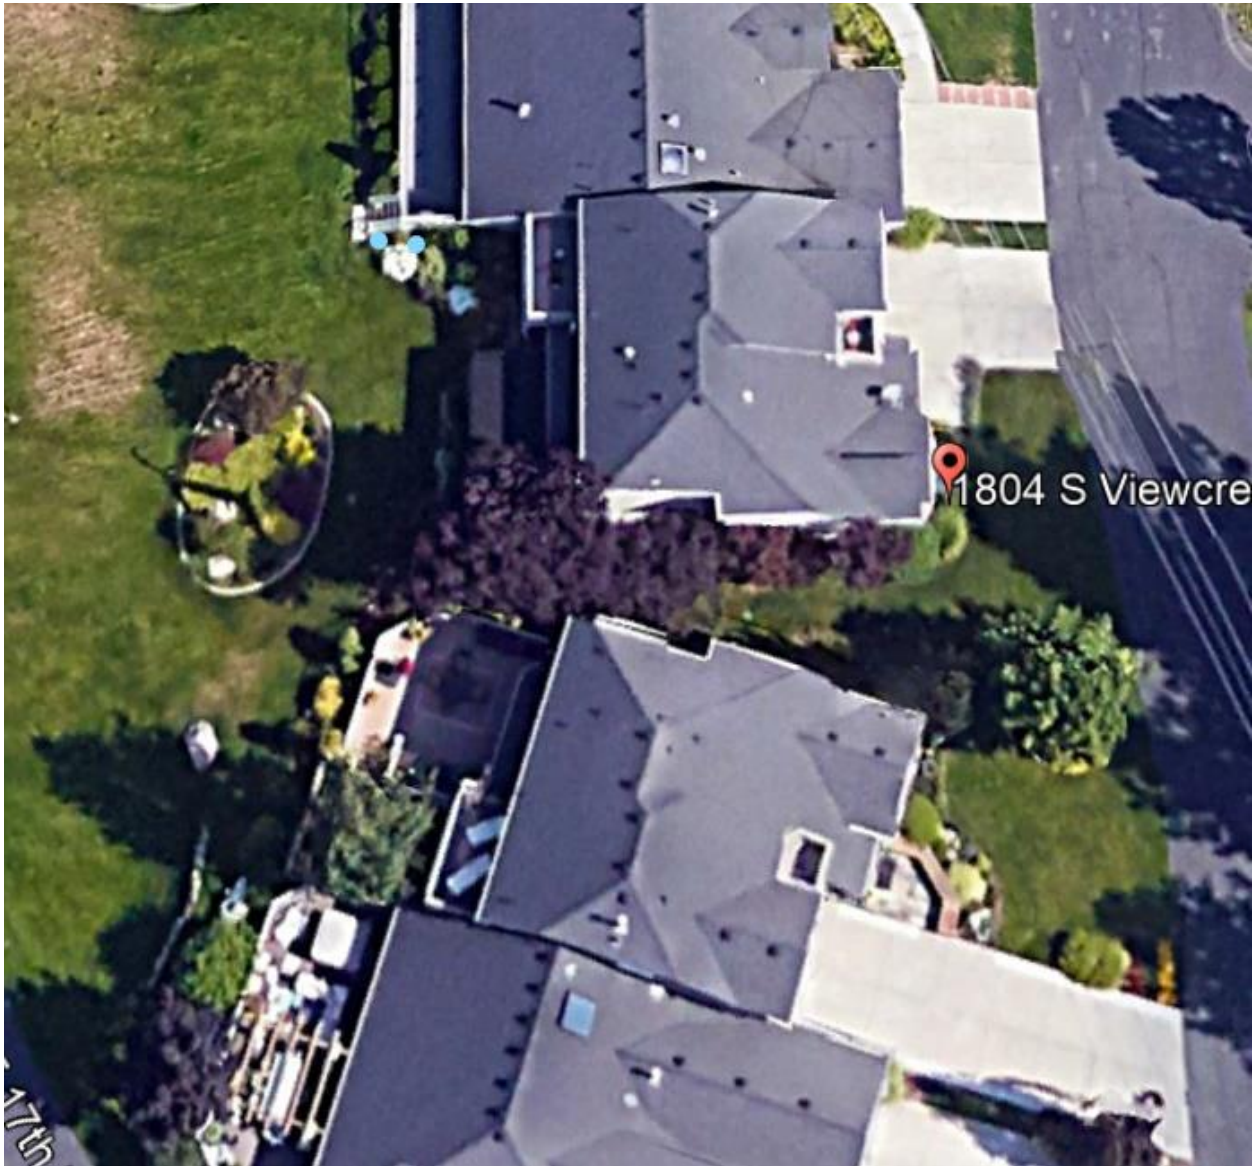
## 1808-1810 Septic Tank Location

The location of the septic tank openings for 1808-1810 are identified by the blue dots in the flower bed on the west side of 1804. The primary opening is covered by small rocks and is 2' south of the 1802 deck, and 2' east of the top of the deck stairs. The second opening was not specifically located, but is anticipated to be 2-3' directly west of the primary opening close to the bottom of the deck stairs. This will likely require the removal of some plants if the second tank is opened up. The depth of the primary tank lid is approximately 10".

Note: Sprinkler lines and a sprinkler head are very close to the tank openings. Dig carefully.

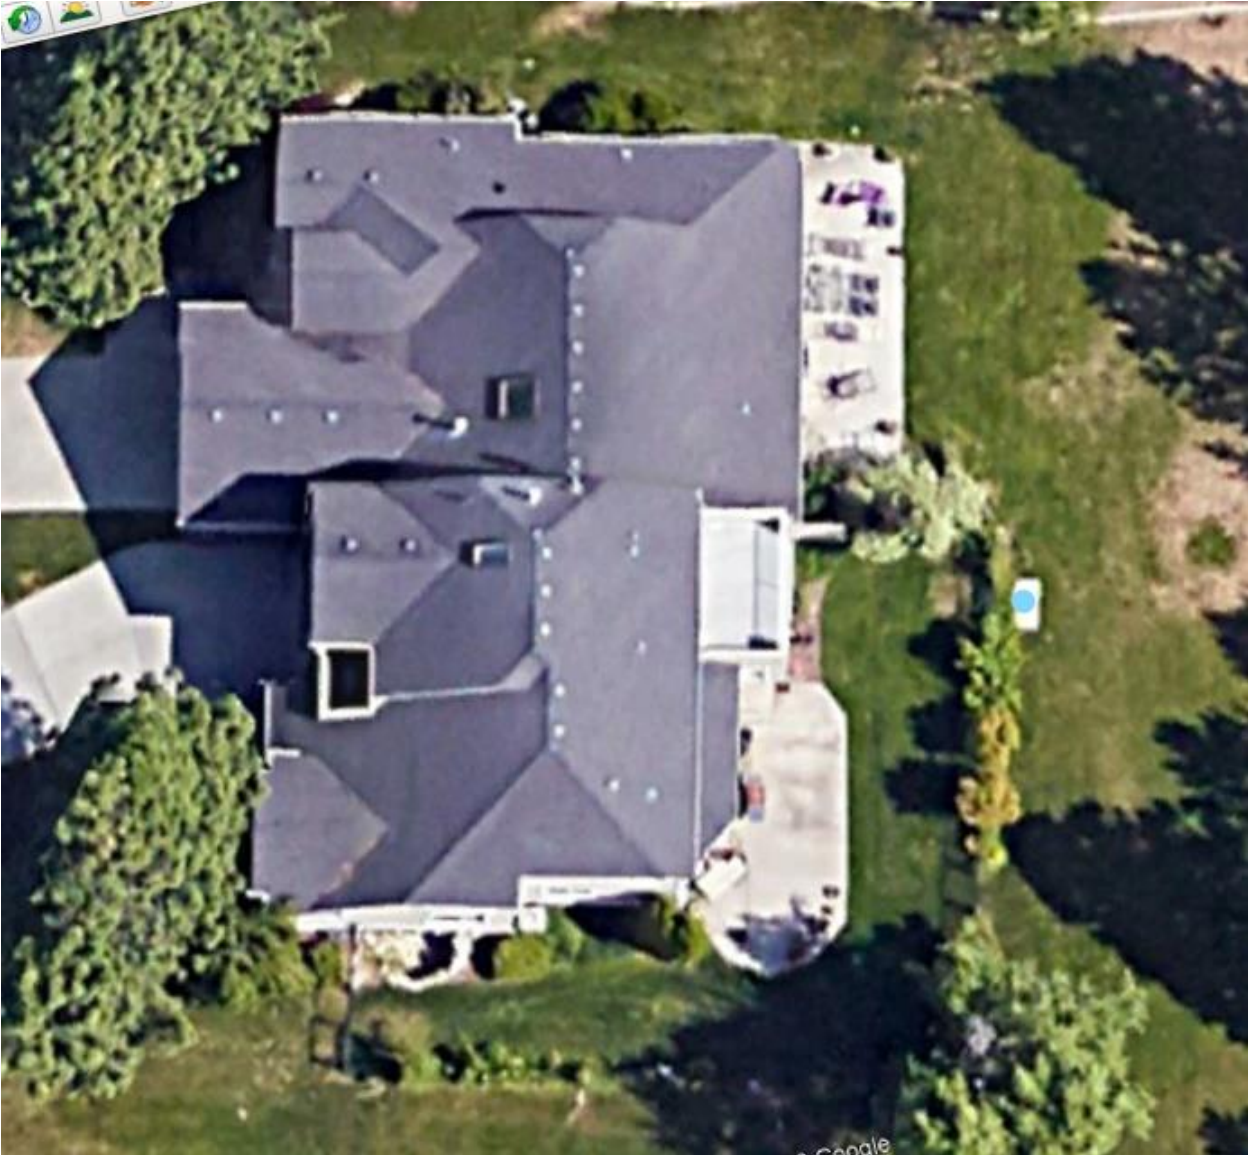
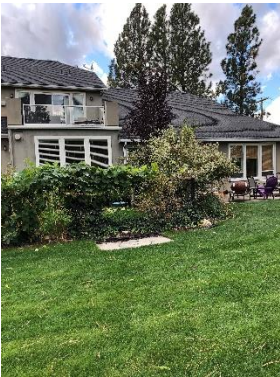
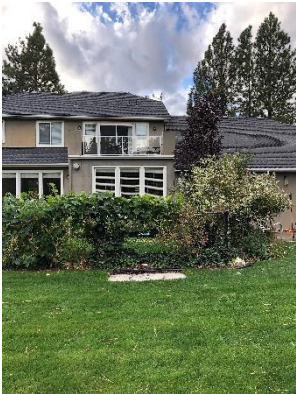
1813-1817 S Viewcrest Lane Septic Tank Location

The septic tank openings for 1813-1817 S Viewcrest Ln are located directly east and just outside the fence of 1817 S Viewcrest Ln. (Note the blue dot.) There is one opening that is within a rectangular concrete pad with a 24” circular lid. It is immediately accessible when the concrete lid is lifted. The actual location of the second opening is not shown here, but the CS Inspection report below gives some indication of its location.

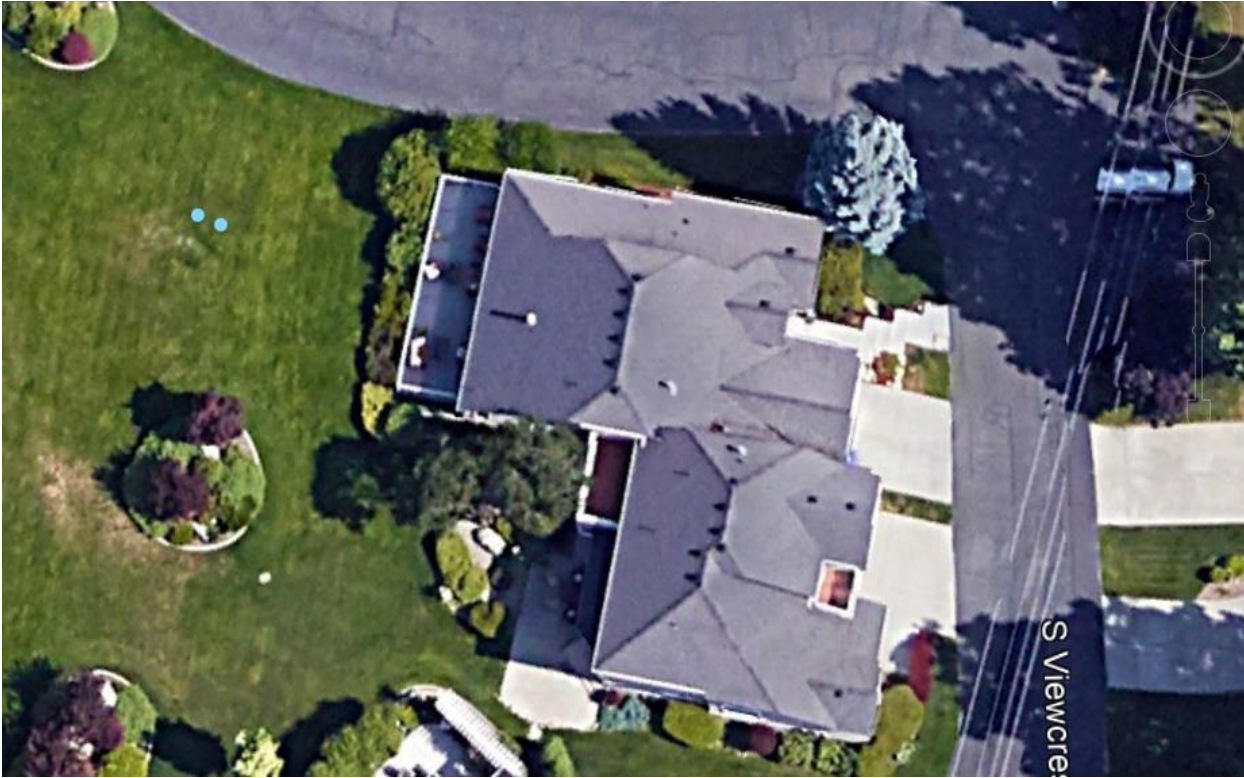
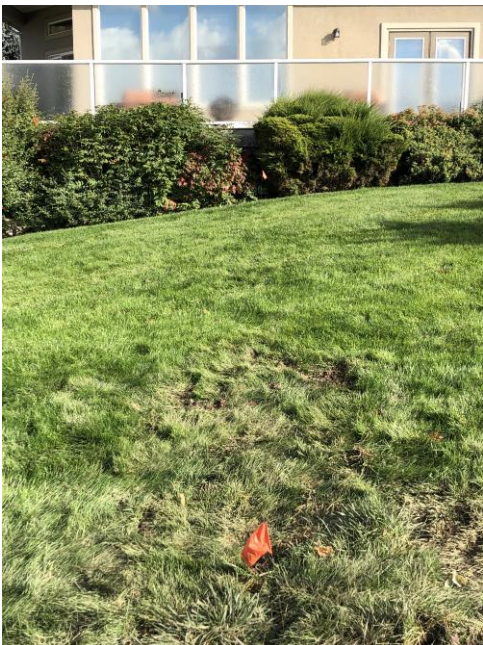
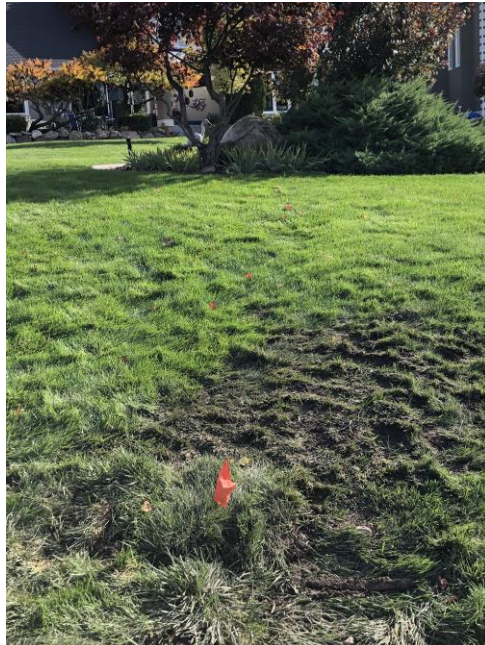
## 1814-1816 Septic Tank Location

The septic tank openings (as indicated by the blue dots) for 1814-1816 are located 39' east of the edge of deck of 1814. They are also located 31' north of the edge of the major rock in the island to the south. The orienting line for the openings is from the south-most window in the four window configuration on the deck of 1814. (See photos below.) The openings are currently 3'6" below ground. During the pumping/inspection done in October of 2020, risers will be installed over the openings so that the access to the openings will be at ground level in the future.

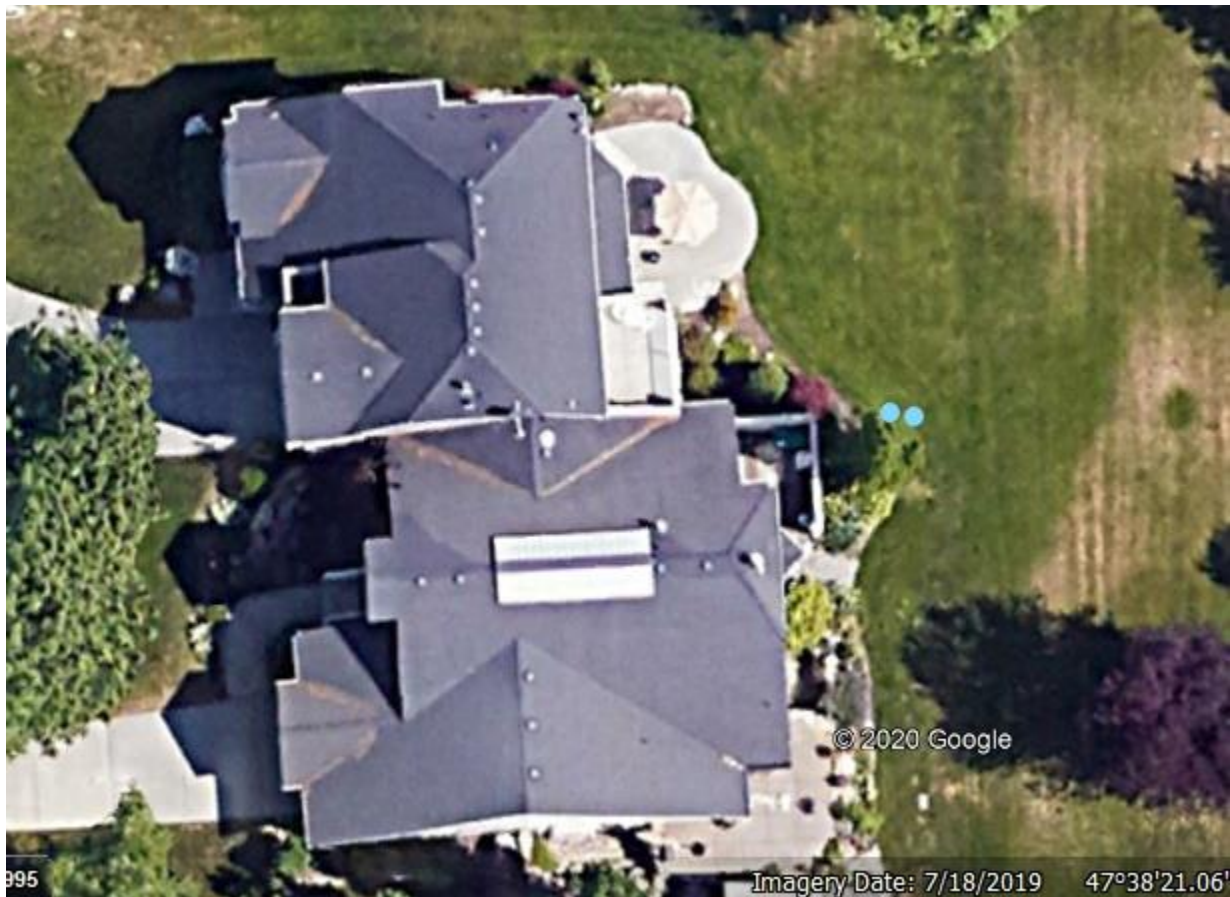
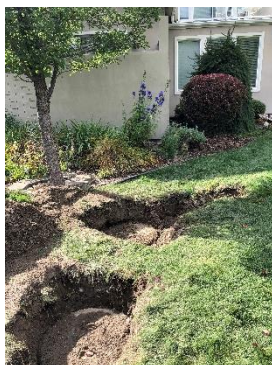
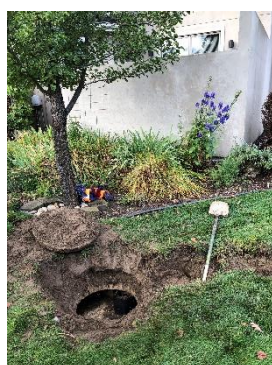
## 1819-1821 S. Viewcrest Ln Septic Tank Location

The septic tank openings for 1819-1821 S. Viewcrest Ln are identified by the two blue dots approximately 12' and 17' east of the SE corner of the NE patio wall of 1821. If you were to draw a straight line extending eastward from the north facing wall of the 1821 patio wall, the openings are approximately 12" south of that imaginary line. The openings are between 12"-14" deep under the grass covering and the openings are 24" in diameter.

Note: There is sprinkler control wiring approximately 1.5-2' to the north of the primary tank opening. The shovel in the second photo below is where the sprinkler electrical wire is located. Dig Carefully.

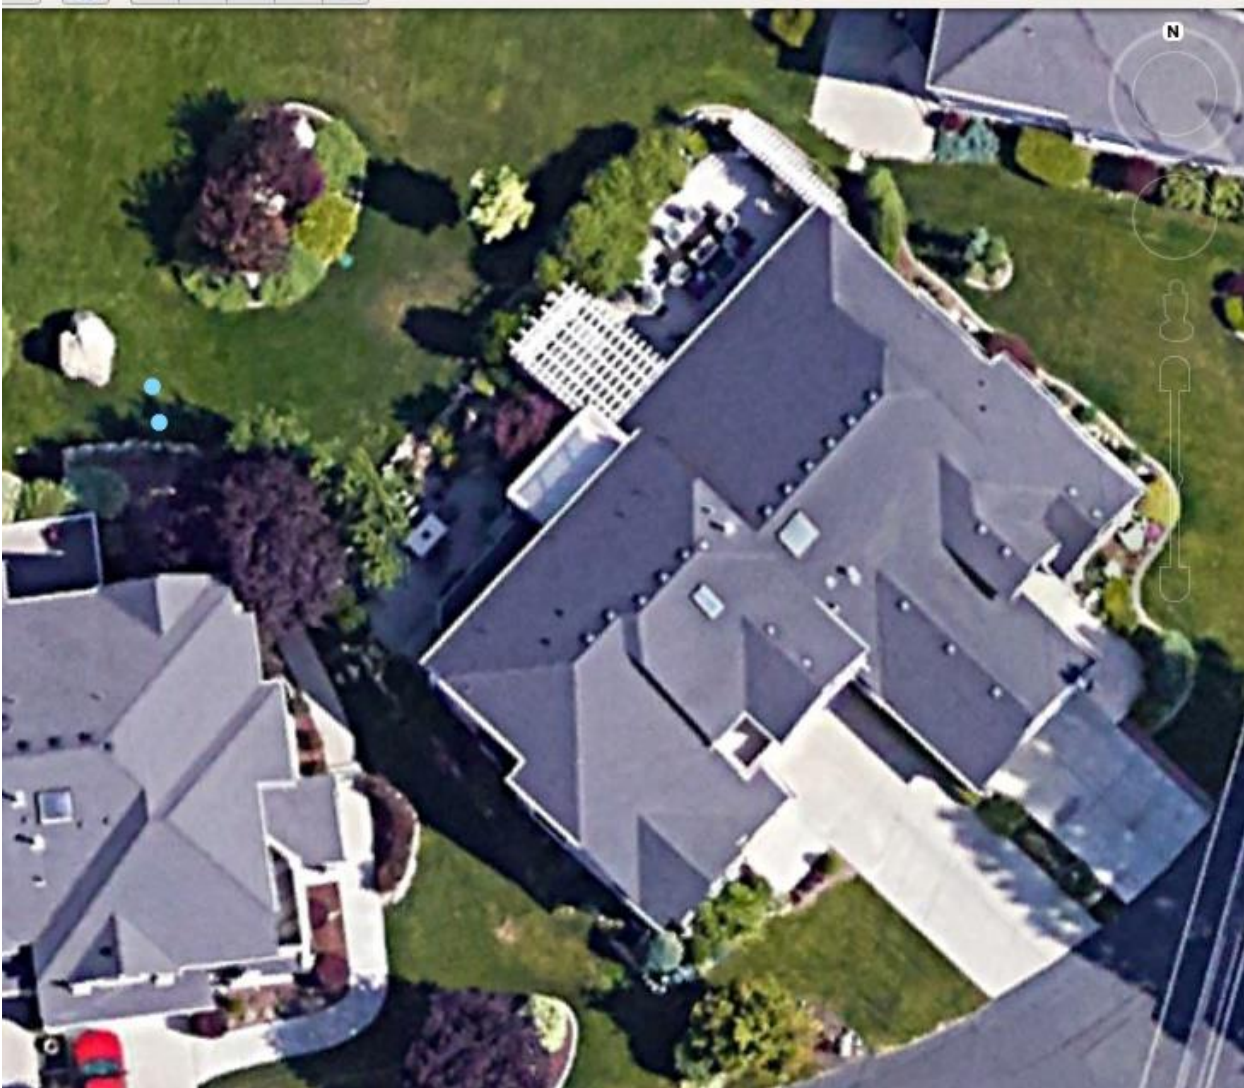
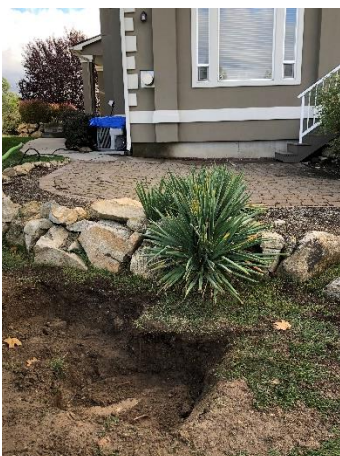
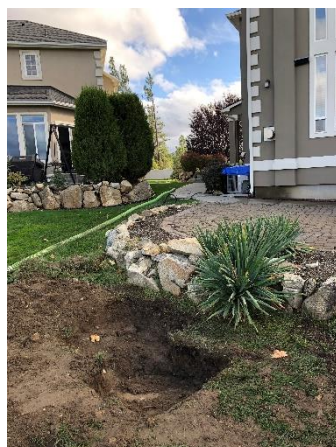
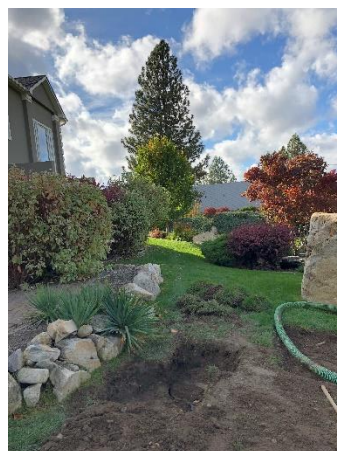
## 1820-1822 Septic Tank Location

The location of the septic tank openings for 1820-1822 are indicated by the two blue dots which are on the north side of the patio of 1826. The primary opening is 39' from the edge of the 1826 building directly north of the west side of the column on the façade of 1826. The primary opening is also 9.5' SE from the corner of the large rock that is just to the NW of the openings. When measured from the rock wall edging the patio, the primary opening is 3' from the edge of the rock wall. Opening # 2 is approximately 3' to the NNW of the primary opening.

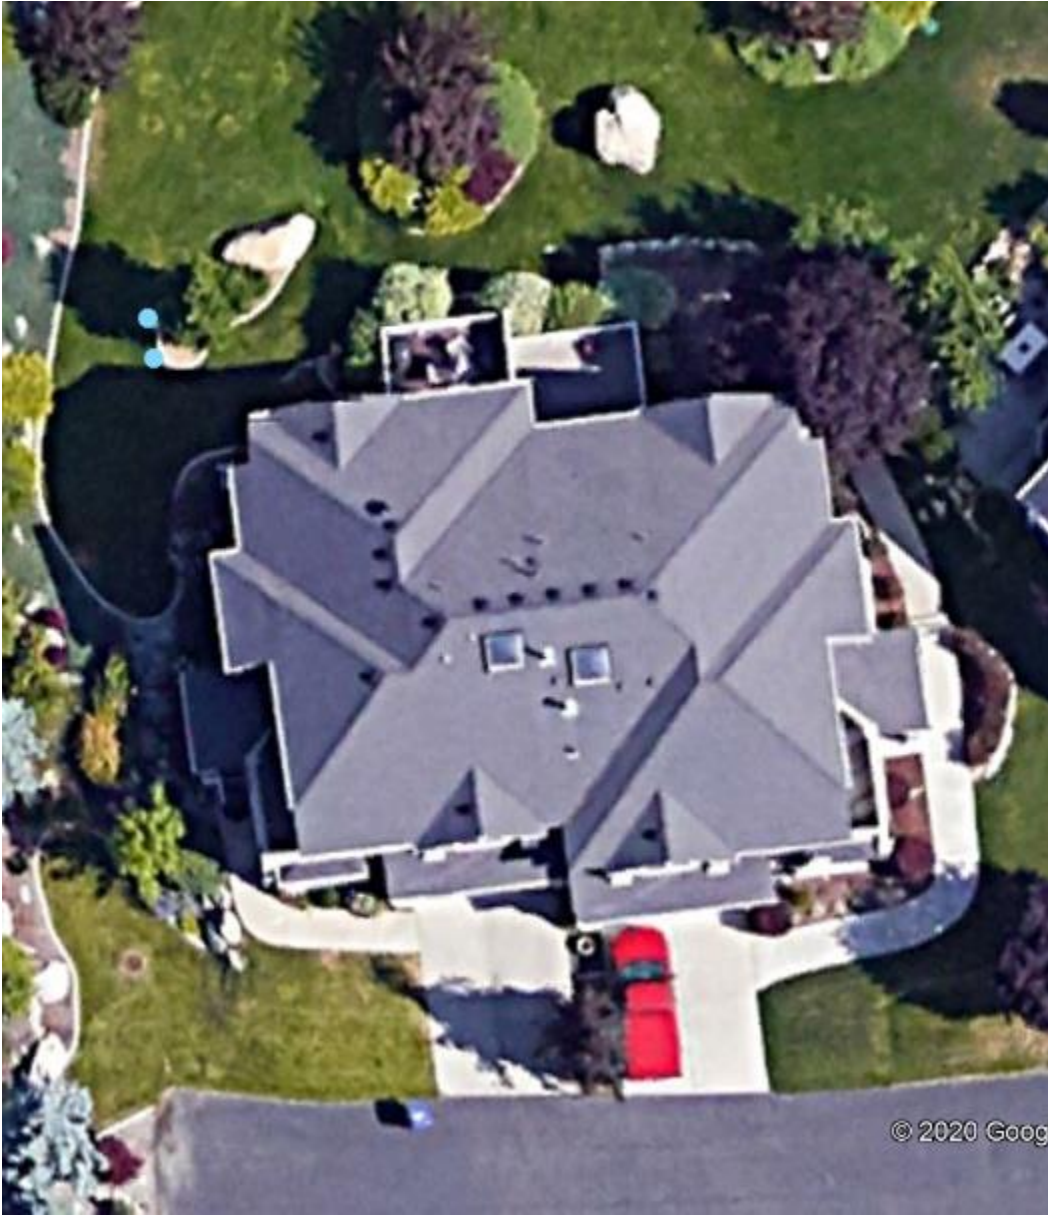
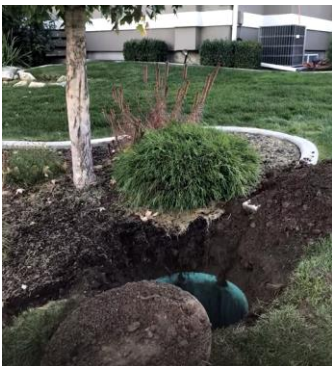
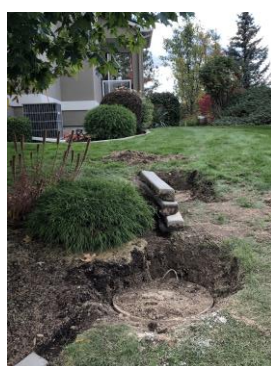
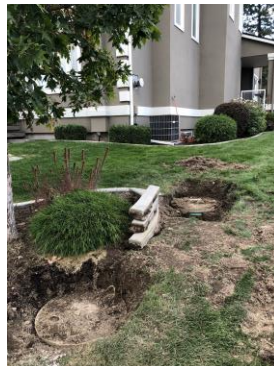
## 1826-1828 S Viewcrest Lane Septic Tank Locations

The septic tank openings for 1826-1828 S Viewcrest Lane are identified by the blue dots on the southwest corner of the curbed island on the NW corner of 1828 S Viewcrest Lane. The openings are between 4" and 12" under the grass. The lids are 24" in diameter. The openings are partially and just slightly under the island curbing which will require three sections of curbing to be pulled up to access the openings.
